AN OPTICAL TECHNIQUE FOR INVESTIGATING

DIELECTRIC BREAKDOWN

A THESIS

DEPARTMENT OF ELECTRICAL ENGINEERING

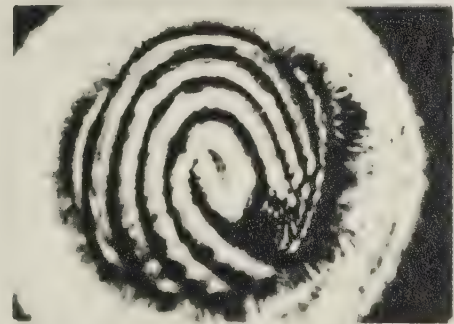
The subsequent frames, of which 10.5.8, 10.5.9 and 10.5.10 taken at  $t = 0.262$ ,  $0.836$  and  $3.146$  seconds respectively are three examples, show a rapid flow of fringes with the collapse of the field. In the last frame the pattern is close to the original form apart from the disturbances due to the crack and the damaged coating.
